North Coast Regional Water Quality Control Board

**Inspection Report for October 15, 2019, Consent Inspection
Humboldt County Assessor's Parcel Numbers 216-303-002 & 216-304-007**

File: Cannabis Program Inspections, Humboldt County, Rowan Leavenworth,
CIWQS Place ID 843434

Physical address: 22525 Alderpoint Road, Alderpoint, CA 95511

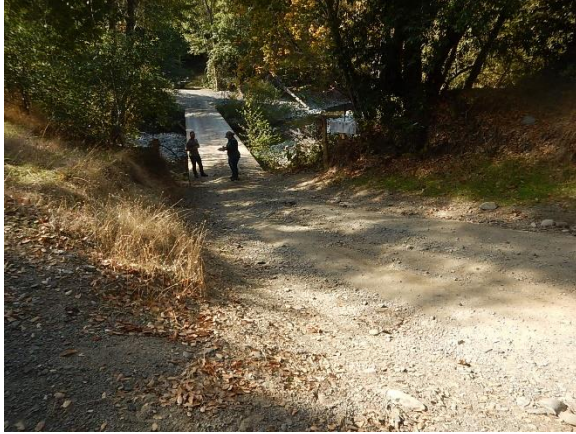
The Property is located in the Dobbyn Creek watershed, with the driveway accessed off Alderpoint Road between the communities of Alderpoint and Blocksburg. A short steep segment of driveway (WQ0) arrives at a bridge over Dobbyn Creek (WQ1). The segment of road is a through cut that drains toward Dobbyn Creek, and based on its condition as observed during the October 15 inspection it is likely to discharge sediment to Dobbyn Creek this winter.

Figure 4. WQ0, access road approach to bridge with high potential for sediment delivery to Dobbyn Creek.

2. WQ0, WQ7: Immediately implement actions to shape, drain, and surface road segments to hydrologically disconnect and prevent and minimize construction-related controllable sediment delivery to watercourses.

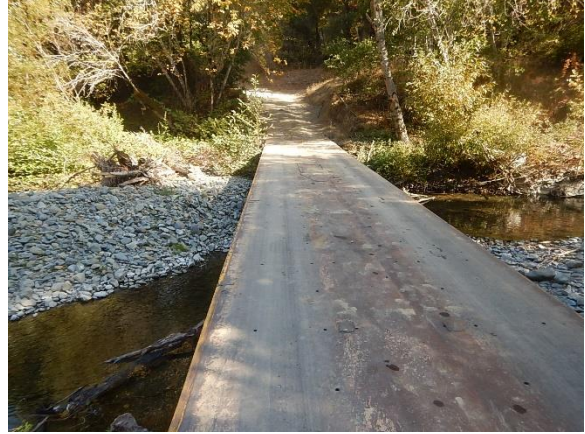
WQ1: The bridge over Dobbyn Creek was installed in 2007. According to the associated 2007 CDFW Lake and Streambed Alteration Agreement, this was to be a temporary bridge, installed and removed seasonally. The bridge was in place at the time of the October 15, 2019, inspection. On October 17, 2019, CDFW issued an NOV, and directed Mr. Leavenworth to remove the bridge by October 31, 2019. On November 4, 2019, I received email notification from TRC advising that the property owner had removed the bridge per the direction from CDFW. Absent the bridge, it does not appear that Mr. Leavenworth has a viable route proposed or in place to access his cannabis cultivation areas.

Figure 6. WQ1. Bridge deck at level with floodplain.

7. Update the WRPP in fulfillment of the State Cannabis Order requirements.
8. WQ1: Provide an access plan for cultivation activities. Without an access plan, the cultivation activities may not be feasible. If access is seasonal, then the site plans and activities need to plan for that while ensuring that water quality is protected.

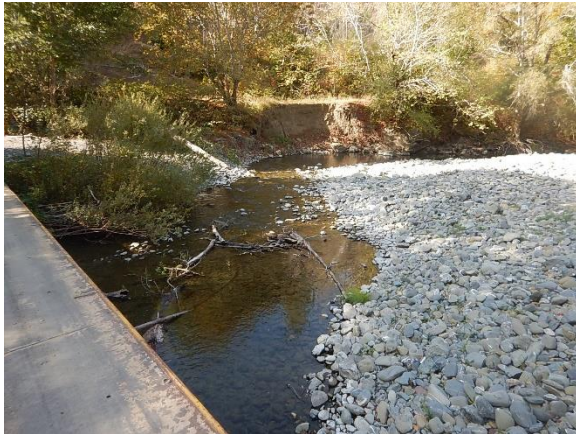
Figure 5. WQ1 (bridge) and WQ2 (bank erosion) at Dobbyn Creek.

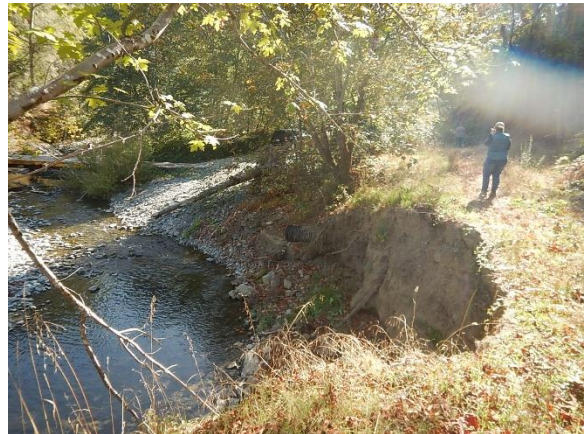
WQ2: Just downstream of the bridge at WQ1, on the western bank, a road parallels Dobbyn Creek. The WRPP identifies this road, and indicates that it is no longer in use, is blocked, and vegetated. The WRPP identifies, as Site 2, a 15" culvert on the road, and describes it as being in adequate condition but with gravel deposits from Dobbyn Creek, resulting from its location in the floodplain. The WRPP does not mention bank erosion that I observed just downstream of the culvert; I estimate approximately 15 yd³ eroded and delivered to Dobbyn Creek. The bank was comprised primarily of fine-grained sediment. It is possible that the erosion occurred since the WRPP was developed or revised.

Figure 7. WQ2 bank erosion, looking upstream. Note culvert just upstream of void.

9. WQ2: Include in WRPP with an estimate on timing of bank erosion delivery. Propose feasible treatment to protect against future delivery.
10. WQ3: Perform maintenance on the culvert, including cleaning the inlet and placing rock at the outlet.

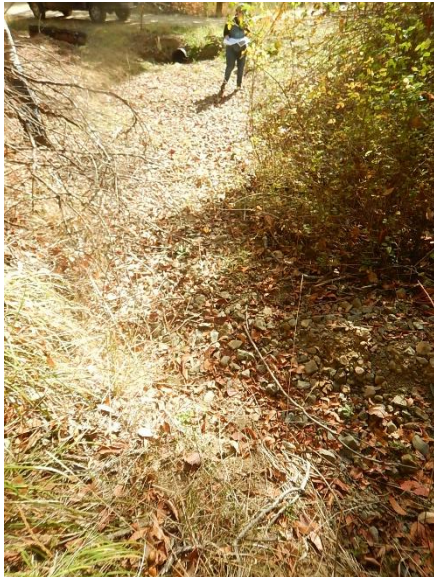
WQ3, WRPP Site 7: Continuing along the access road, Site 7 is an 18-inch culverted Class II watercourse crossing. A road drainage ditch delivers directly to the watercourse at this crossing. At present, the crossing comprises relatively minimal fill in the stream channel. As the watercourse transports a significant volume of bedload, likely due to a landslide and gully upstream, the WRPP specifies replacing the 18-inch culvert with a 42-inch culvert, consequently placing a large volume of fill into the stream as part of the installation. To minimize the amount of fill to be placed or added to this crossing, we discussed the potential to develop a site-specific alternative strategy for this crossing, such as constructing an armored fill and allowing only seasonal use.

Figure 8. WQ3 inlet of crossing 7. Note minimal fill and channel width.

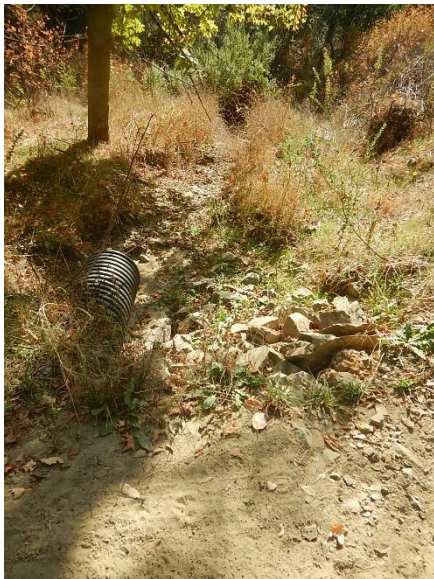
Figure 9. WQ3 outlet of Crossing 7.

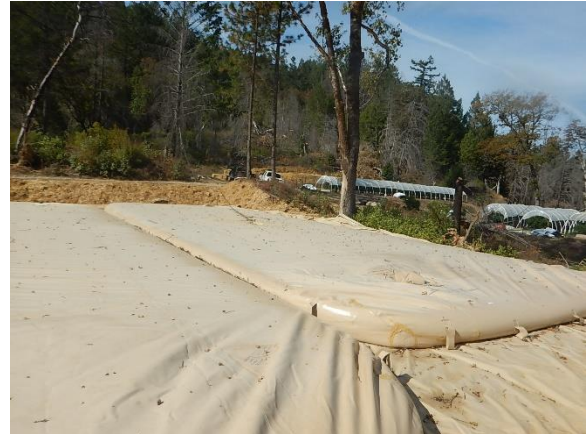
WQ4, WRPP CA A: At CA A, the easternmost of the six mapped cannabis cultivation areas on the site, I observed vegetation and hydrology indicators (inspection point WQ4) that lead me to believe that the watercourse through CA A has associated wetlands. Within this area, the WRPP identifies one culvert, Site 8, a 15" ditch relief culvert, and does not propose any corrective action. The WRPP does not identify wetlands in this area and does not provide for either wetland or riparian protection provisions. As noted below, I recommend that the watercourse and any associated wetlands in this area be correctly assessed and protected, consistent with the State Cannabis Order. Cultivation materials should be removed from setback and stabilized immediately, and the site winterized. At CA A, I observed water storage bladders (inspection point WQ5). These bladders, like all other water storage bladders I observed of the Property, lacked secondary containment. Secondary containment for the bladders at this location would require additional land disturbance and would expand the developed footprint. Given the presence of and proximity to wetlands and the watercourse in this area, CA A may not be feasible for cultivation and water storage. If CA A is decommissioned, I recommend that the flats be recontoured using "light-touch" practices to lay back fill slopes and cut-banks.

Figure 10. WQ4 and WQ5. Bladders and cultivation at CA A.

11. WQ4, WQ8: Wetland delineation and restoration:
 - a. Engage an appropriately licensed, qualified professional to conduct a forensic wetland delineation, following applicable U.S. Army Corps of Engineers procedures and protocols, at WQ4 and WQ8.

- b. Engage an appropriately qualified professional with relevant experience in wetland restoration to prepare and submit a wetland restoration plan for WQ4 and WQ8 which includes but is not limited to, a project description, goal of restoration, implementation plan and schedule, plan for monitoring and site maintenance following restoration, and contingency measures addressing the diversity index of wetland/ non-wetland native plant species occurring on the Property. The plan should include proposed mitigation to address the temporal and permanent losses of wetland value and function. The plan should include specifications for debris removal and disposal.

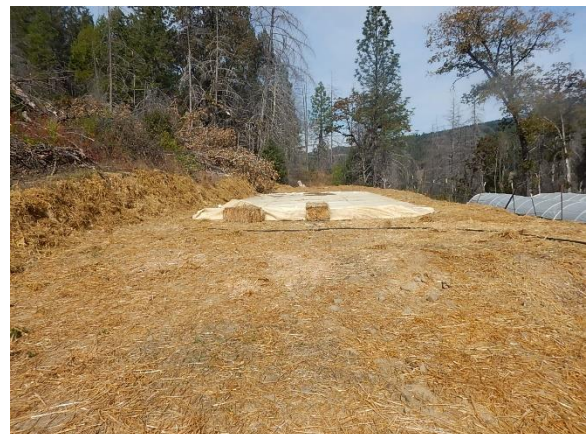
Figure 12. WQ 5. Bladders at CA A.

12. WQ5, WQ19: Provide a water plan for the Property in conformance with the statewide cannabis order, including plans for addressing containment of bladders, stability of ponds, well water, and storage.

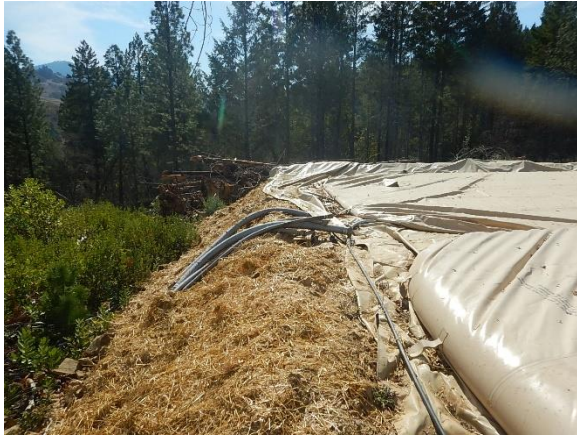
Figure 13. WQ5. Bladders at CA A without containment. Fill was covered in straw.

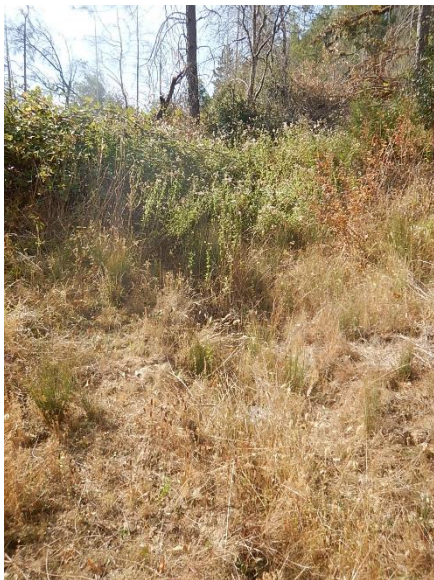
Figure 14. WQ 4. Watercourse upstream of CA A and a defined bed and banks.

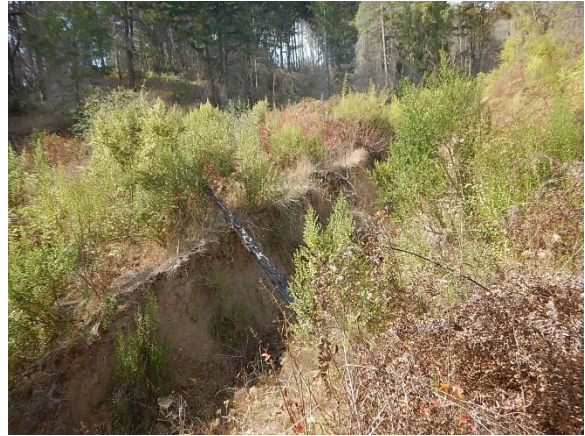
WQ6: West of CA A, downstream of WRPP Site 10, a gully has formed on the watercourse between WRPP Sites 9 and 10 (note, this is same watercourse described in WQ4). Adjacent to the gully is a water tank, within 20' of the watercourse, apparently used in part to fertilize plants at CA A. I observed an accumulation of blue crystal fertilizer and algae growth on the top of the tank.

Figure 15. WQ6. Gullied watercourse below Site 10.

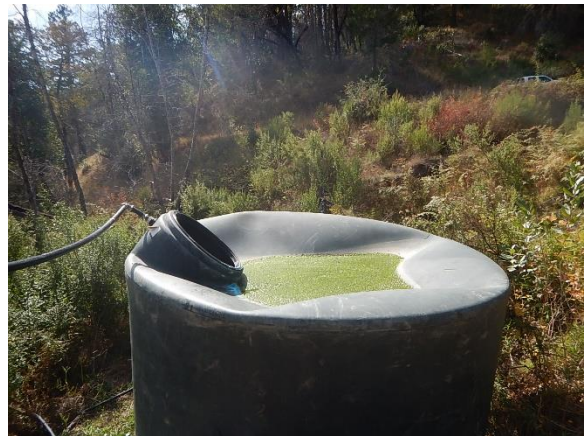
Figure 16. WQ6. Feed tank located next to gullied watercourse, with blue crystal fertilizer accumulation on top and associated algae bloom.

4. Immediately remove all fertilizers from setbacks, including feed tanks, empty containers, and storage of fertilizer, including in sheds.
5. Immediately store and contain all chemicals, including petroleum, fertilizer and/or pesticides properly to prevent spillage and discharge to receiving waters. Provide adequate secondary containment for all petroleum products.

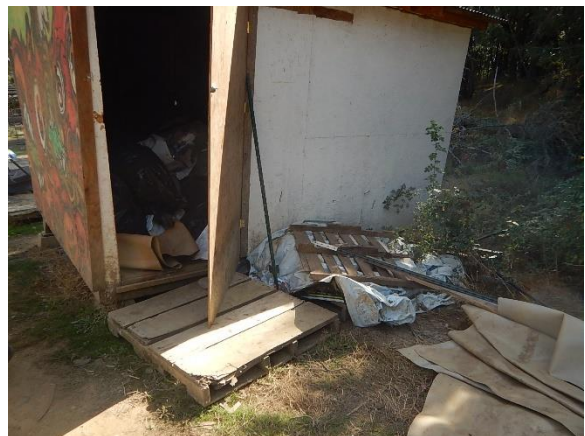
WQ7: Just south of cultivation area CA B, at a site the WRPP identifies as Site 17, there are storage structures associated with cannabis cultivation activities, adjacent to a Class II watercourse. Along the access road nearby, at WRPP Site 18, concentrated road runoff has eroded the road surface, and I observed that this road segment is hydrologically connected to a watercourse. The WRPP indicates that corrective work at Sites 17 and 18 was to have been completed by October 15, 2019, the date of the inspection. We observed that work had not been completed, and no interim measures had been implemented. Without treatment, the eroding road segment at Site 18 will deliver fine sediment to a watercourse.

Figure 17. WQ7. Cultivation related infrastructure in setbacks at CA B.

3. WQ4, WQ6, WQ7, WQ8: Immediately remove materials associated with cultivation and related activities from locations that are within the riparian and wetland protection setbacks specified in the statewide cannabis order.

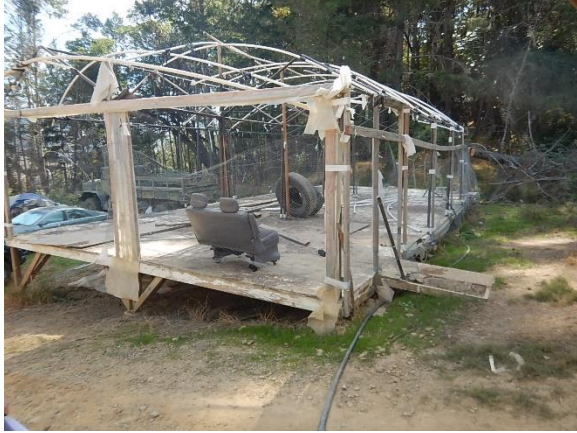
Figure 18. WQ7. Cultivation-related infrastructure in watercourse setbacks at CA B.

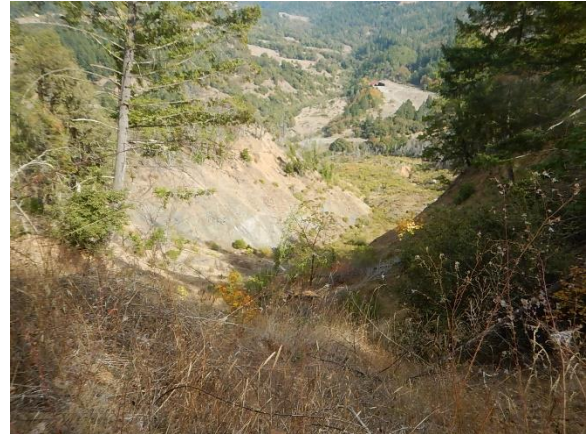
Figure 20. Looking down a portion of the large landslide scar toward Dobbyn Creek.

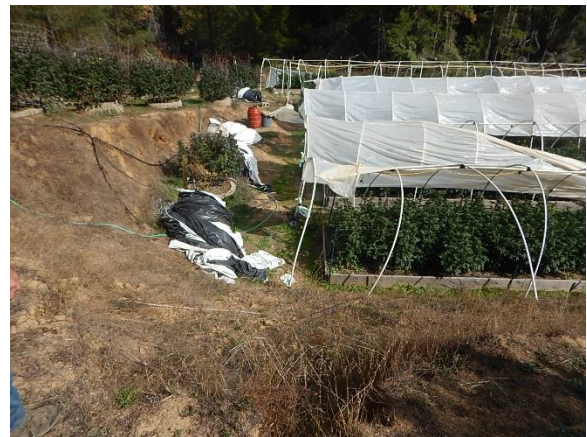
WQ8 & WQ9, WRPP Site 19, CA C: Cultivation area CA C is accessed via a spur road heading south from the access road, and is a cut and fill flat, with the cut bank approximately 10' high. The WRPP indicates that the cut bank has a seep and that the cultivation area is upslope of a seasonal wet area. However, the toe of the fill appears to encroach into a wetland. I observed surface water and hydrophytic vegetation. Water from the seep (WQ9) flows into the cultivation area, where it can contact and carry pollutants from the cultivation area to the wetland (WQ8).

Figure 22. WQ9. Cutbank at CA C

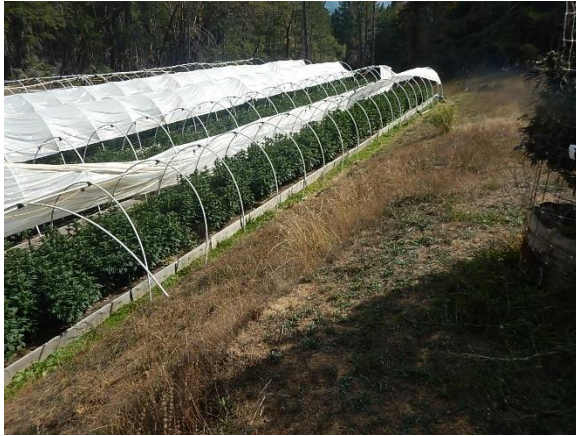
Figure 23. CA C with flow path from seep at WQ9 along hoop house to fill slope and wetland.

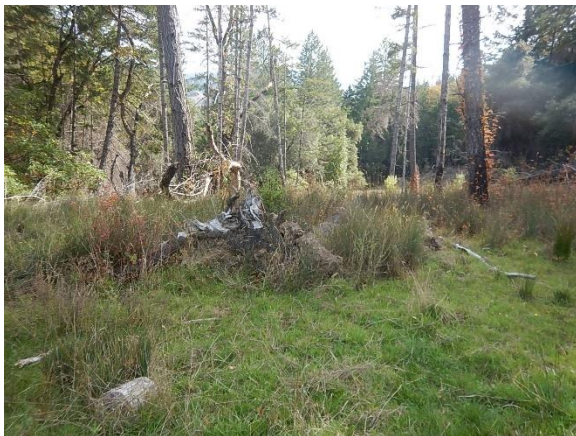
Figure 24. WQ8. Potential wetlands below CA C

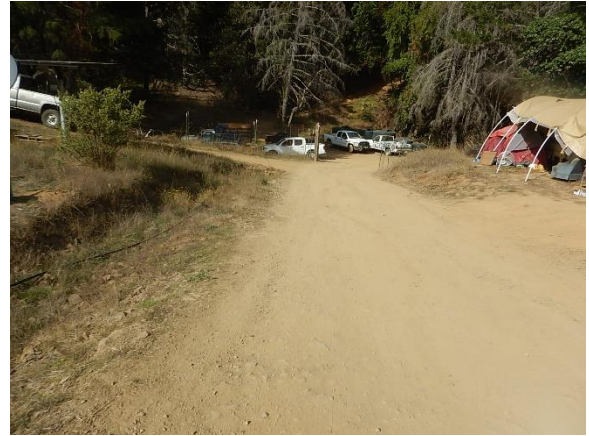
WQ11: West of CA C the access road ends at the main cultivation area CA D, where development and activities include cannabis cultivation, camping, a harvesting/processing building, porto-potties, fuels and generators, water storage, composting, refuse storage, and domestic uses. There were numerous employees present in this area during the inspection. Just before reaching CA D, the main access road intersects with a road that traverses the forest to cultivation areas CA G, CA F, and CA E (secondary road). The intersection area is used for parking, a well, water storage tanks, and a shed with fertilizer storage. Stormwater from the developed areas around CA D concentrates and drains down to the same watercourse threatened by WQ10. Consequently, pollutants associated with cannabis cultivation and associated activities in this area can be transported to the watercourse.

Figure 25. WQ11. Developed surfaces at CA D are hydrologically-connected to the watercourse

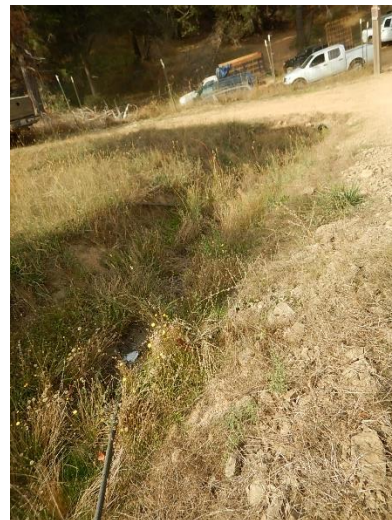
WQ12: I observed an inside ditch along the secondary road, just north of the intersection with the access road. Greywater was actively discharging on the surface into the ditch from what appeared to be a sink. The ditch drains through a DRC to another ditch that has the potential to discharge to the watercourse mentioned in WQ10 and WQ11.

Figure 26. WQ12. Greywater pipe into ditch

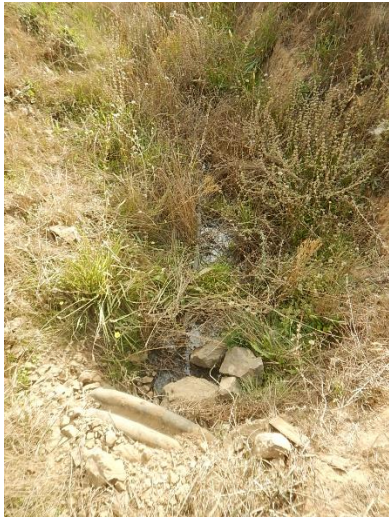
Figure 27. WQ12. Greywater entering ditch relief culvert

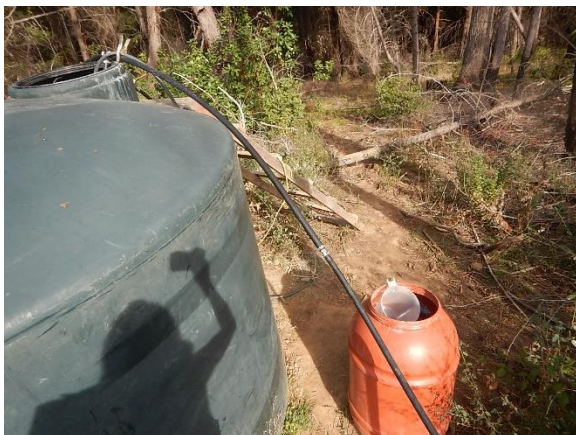
Figure 29. WQ11. Feed tank with fertilizer residual on tank.

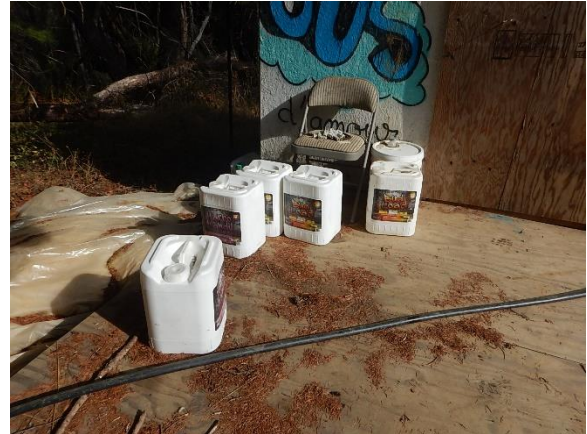
Figure 30. WQ11. Fertilizer stored in watercourse setback.

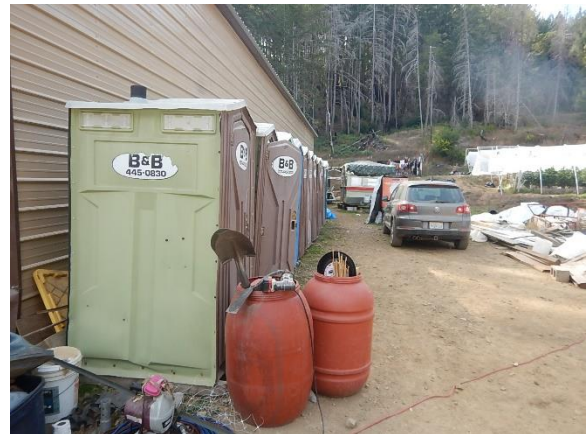
WQ14: Along the building, I observed a line of porto-potties.

Figure 31. WQ14. Processing facility and porto-potties at CA D

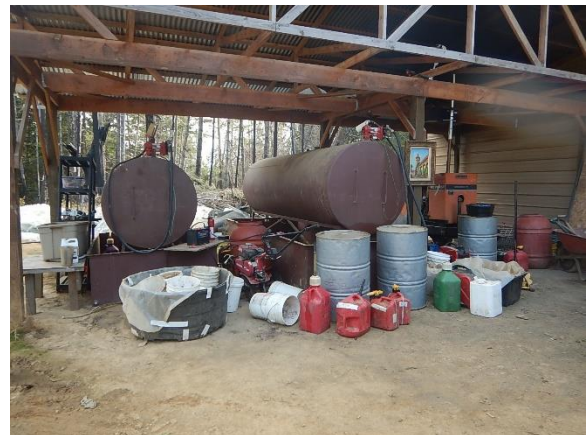
WQ13: In the middle of CA D I observed a large building with a shed roof extending from one side. Under the roof, on bare dirt, is the generator and fuel storage and use area. It appears that temporary BMPs had been implemented to minimize petroleum releases to the environment, including trays and tarps. However, it appears that BMPs have not been maintained nor have more permanent solutions been implemented.

Figure 32. WQ13. Fuels at CA D and Processing facility.

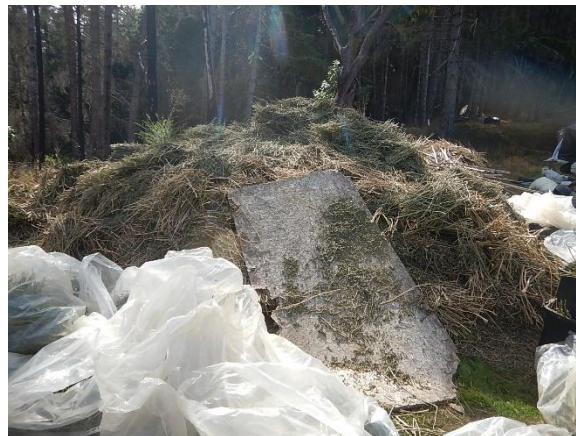
10. Cultivation-related wastes: I observed compost piles of stacks and root balls located near the petroleum and Pond 1 at WQ15; the piles lacked containment or covering.

Figure 36. Pile of stalks near building.

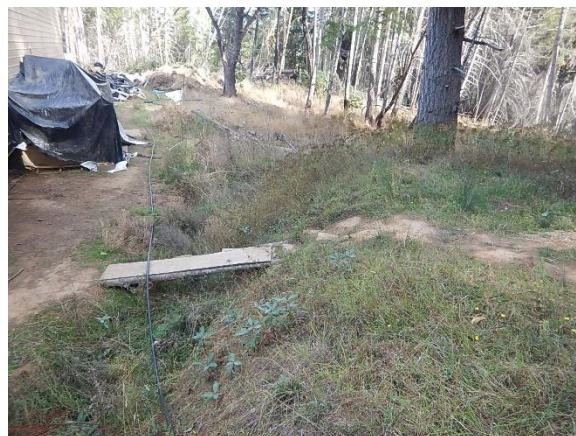
Figure 37. WQ15. Ditch near house leading to Pond 1

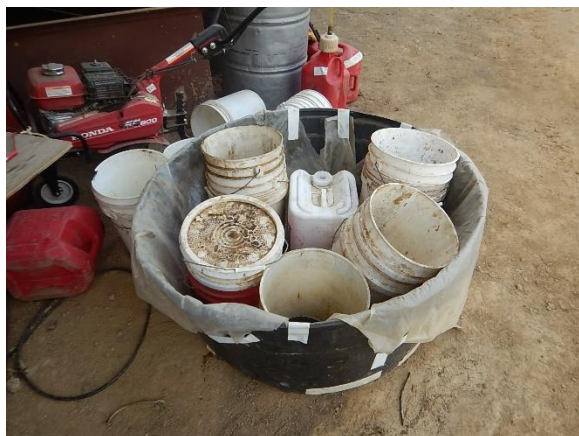
Figure 35. WQ13. Interim BMPS.

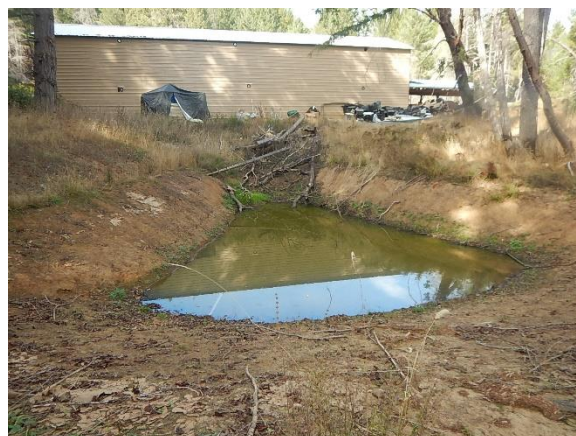
WQ15: Also adjacent to the building, I observed an unlined pond (Pond 1), that did not appear to be onstream. Vegetation lines around the pond indicates that the pond fills. The outlet did not appear eroded, nor did the berm appear cracked. However, the pond lacks a spillway, and the existing outlet does not provide for adequate freeboard to prevent the pond from overtopping.

Figure 38. WQ15. Pond 1.

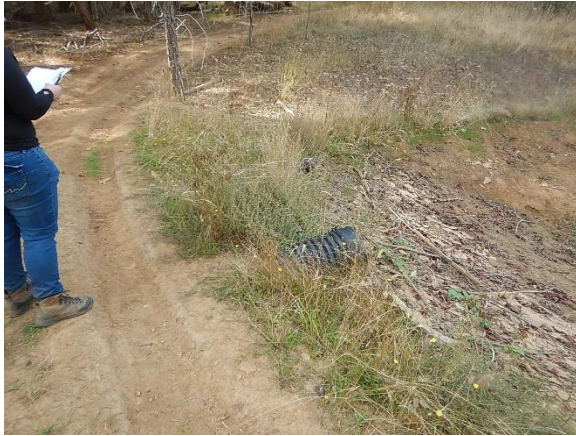
Figure 39. WQ15. Pond 1 outflow pipe inlet

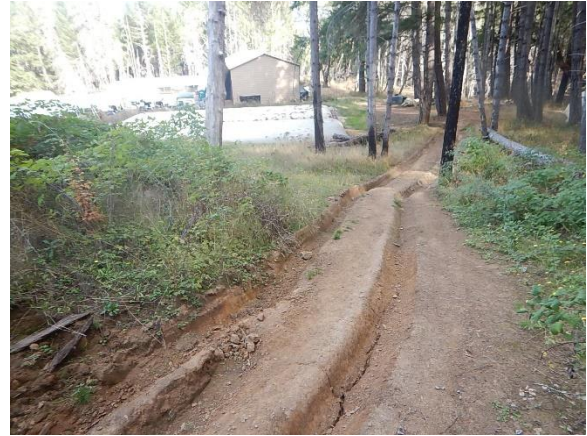
WQ16: Upslope and west of Pond 1 is a second pond (Pond 2; WQ17), accessed via a quad trail with deep ruts (WQ16), apparently due to wet weather use and poor drainage. The WRPP identifies Site 27 as a failing waterbar needed to drain a wet area located below Pond 2, across the quad trail, as water is pooling on the road.

Figure 42. WQ16. Rutted road between Pond 1 and Pond 2.

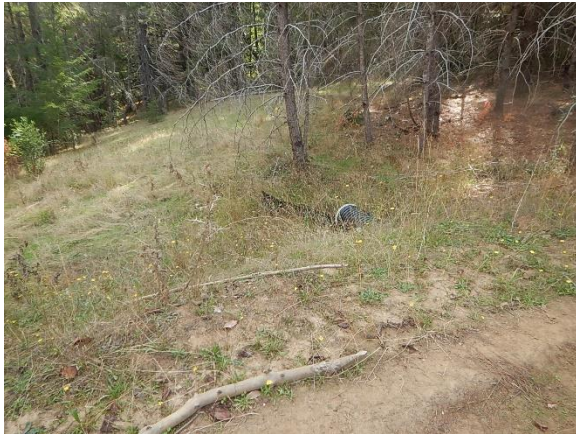
Figure 40. WQ15. Pond 1 outflow pipe outlet.

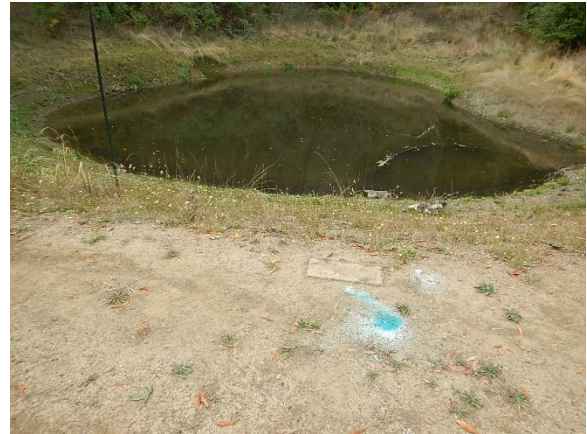
Figure 43. WQ17. Blue crystal fertilizer on Pond 2 berm, looking upslope from embankment. Pond 2 has quite a bit of water in it.

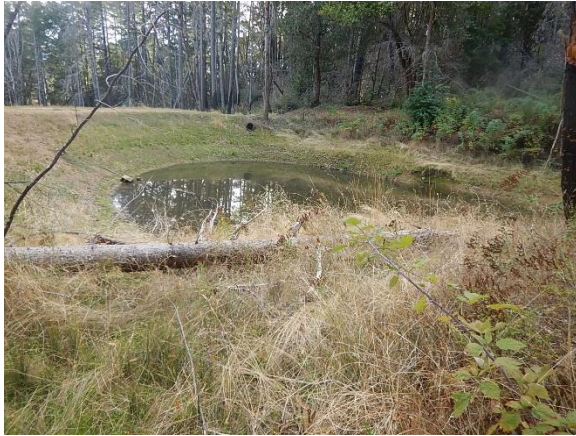
WQ17: Pond 2 is the larger of the two unlined ponds. The area upslope of the pond is heavily vegetated with berries impeding access, and due to the significant instability in the area, hillslope hydrology appears disturbed; that said, based on my field observations I did not identify a channel upslope of the pond. The interior and exterior slopes and freeboard appear to be acceptable. The exterior of the berm exhibited some cracking, beyond just wet and drying cracks, warranting a geotechnical evaluation of the pond, including stability assessment and as-built plans.

Figure 44. WQ17. Pond 2 looking downstream at embankment and overflow pipe.

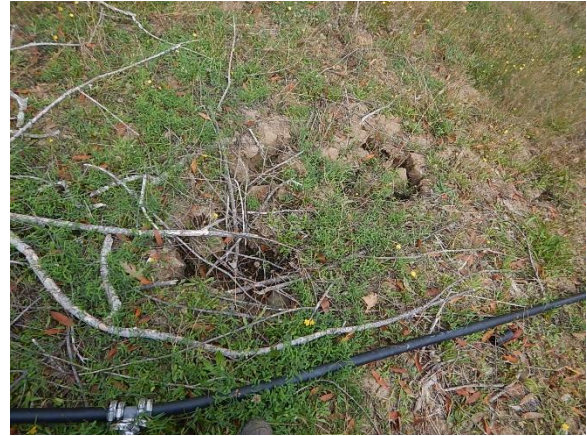
Figure 47. WQ17. Different cracks in Pond 2 berm.

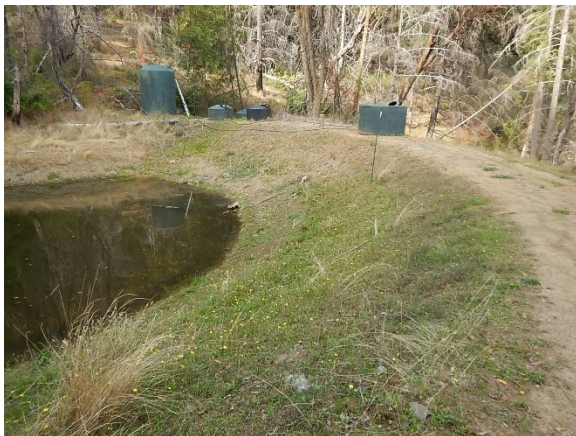
Figure 45. WQ17. Tanks are located on Pond 2 berm.

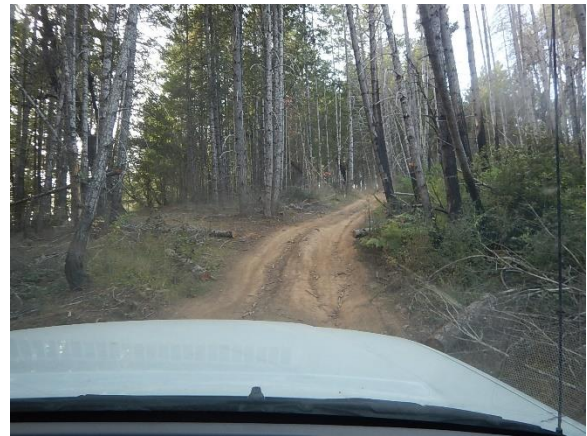
WQ18: The segment of the secondary road between CA G to CA E lacks adequate surface drainage and is rutting. The WRPP identifies surface drainage structures needed to meet Regional Cannabis Order requirements to be implemented by October 15, 2019. There was no evidence of corrective work completed or underway along this road segment.

Figure 48. WQ18. Road between CA D and CA G is rutted

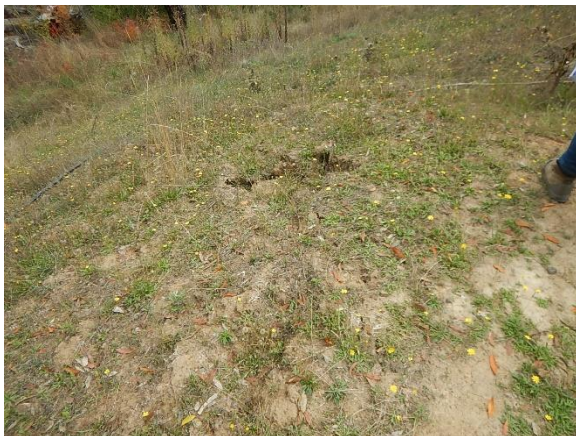
Figure 46. WQ17. Cracks in berm of Pond 2.

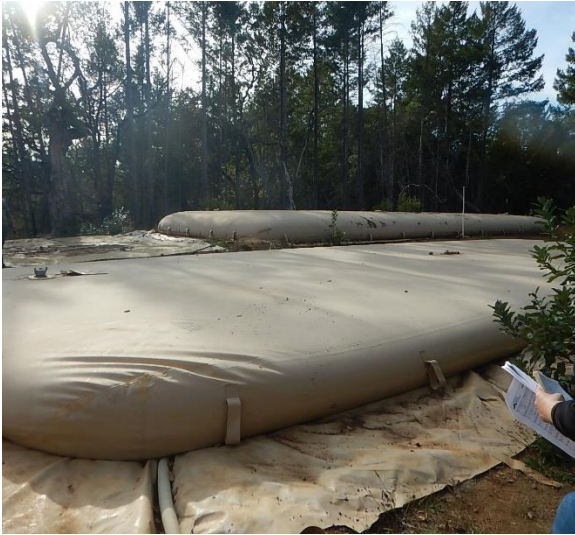
WQ19: At this inspection point, between CAG and CA F, is a flat with water bladders that do not have secondary containment.

Figure 50. WQ19. Bladders between CA G and CA F.

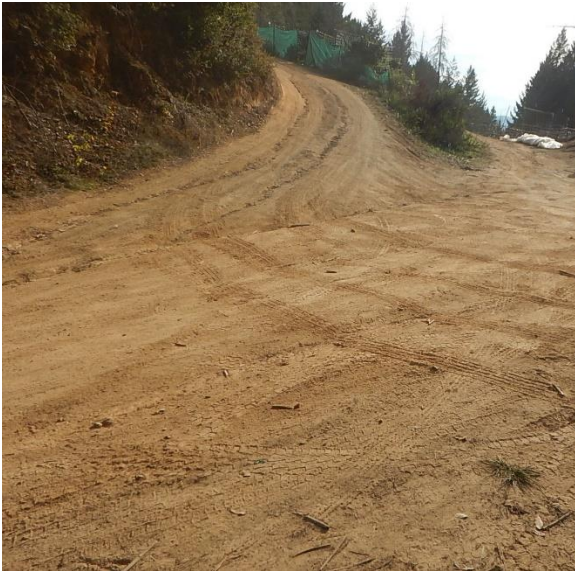
Figure 51. WQ18. Road between bladders and CA F is rutted.

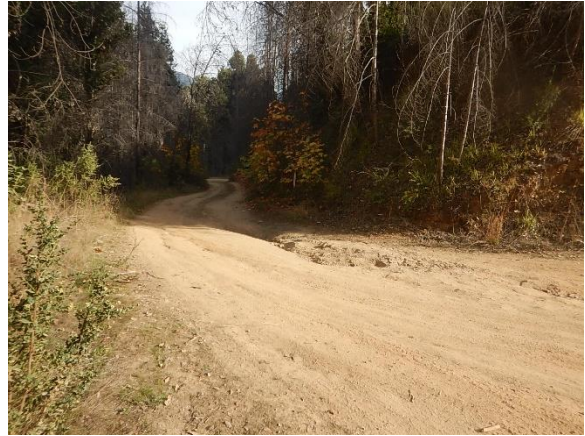
Figure 52. Road from CA F is rutted
